MANDATORY BULLETIN

Number: UFM-13 – 2/2009

UFM-11 – 1/2009

Aircraft check and elevator hungs improvements on a stabilizer procedure.

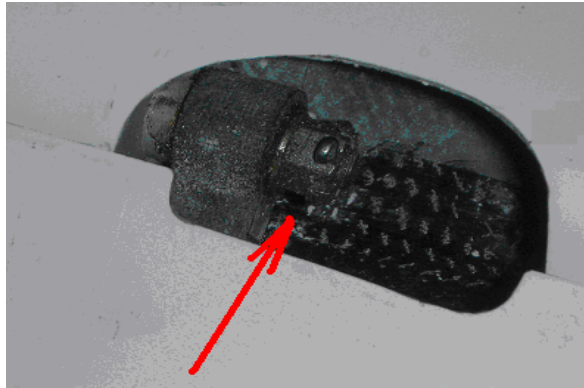
1. Dismount the elevator according to the description in Flight manual – aircraft assembly and disassembly.
2. Place the elevator at a suitable place, remove the main middle hinge castle nut security pin, loosen and unscrew the nut and put it at a predefined place (on older aircrafts there is a self locking nut with additional safety Loctitte lock instead of a castle nut with a security pin).

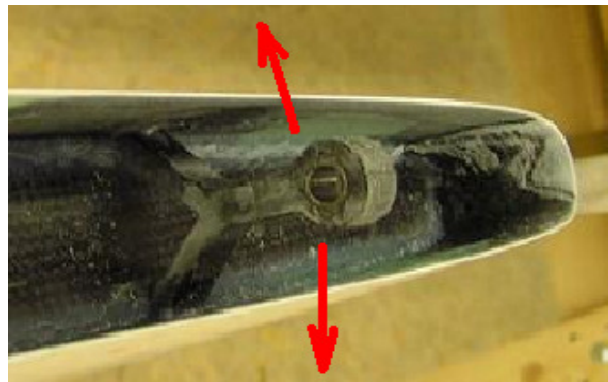
3. Push out carefully the control surface hinges from the stabilizer hungs. Slightly push the control surface in axial direction to the hung axis and at the same time swing the control surface in its deflections. When the middle hinge gets out of the hung then remove the control surface backwards.
4. Check the condition of elevator hungs. Take the hung by hand at the place of turning axis and push slightly (cca 5-10 N) upwards – backwards and check if the hung is hard and if there are no traces of damage or delamination.

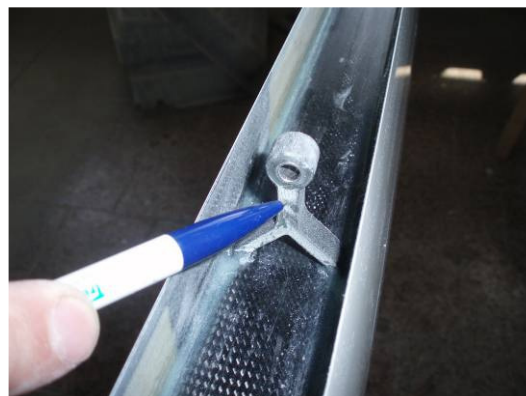
Check if there are delamination traces – unstuck hung in the centre according to following picture.

5. If traces of delamination are found – unstuck fabric in the centre, middle hung repair must be carried out according to articles 7 - 16 of this bulletin, other hungs repair must be carried out according to articles 16 - 20 of this bulletin.
6. **ATTENTION.** If any fissures are found, please consult the repair procedure or the necessity of whole damaged hung change with a below standing contact person

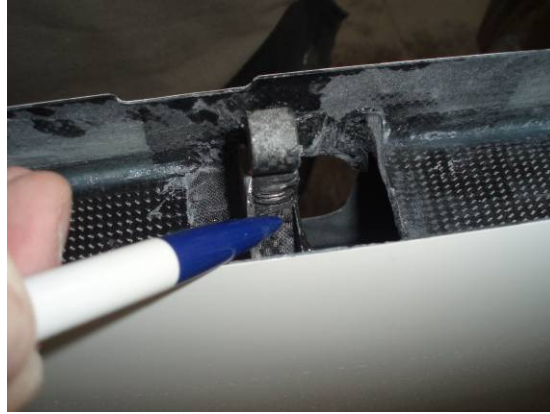
According the next picture check the opposite side when pushing up and down if there is no damage of fabrics or any fissure.
